**DEPARTMENT OF TRANSPORTATION**

Contract #: 04-0120F4Cty: SF/ALA Rte: 80 PM: 13.2/13.9File #: 69.28**WELDING INSPECTION REPORT****Resident Engineer:**Pursell, Gary**Address:** 333 Burma Road**City:** Oakland, CA 94607**Report No:** WIR-006463**Date Inspected:** 18-Apr-2009**Project Name:** SAS Superstructure**OSM Arrival Time:** 1845**Prime Contractor:** American Bridge/Fluor Enterprises, a JV**OSM Departure Time:** 645**Contractor:** Zhenhua Port Machinery Company, Ltd (ZPMC), Changxing Island **Location:** Shanghai, China**CWI Name:** See Below**CWI Present:** Yes No**Inspected CWI report:** Yes No N/A**Rod Oven in Use:** Yes No N/A**Electrode to specification:** Yes No N/A**Weld Procedures Followed:** Yes No N/A**Qualified Welders:** Yes No N/A**Verified Joint Fit-up:** Yes No N/A**Approved Drawings:** Yes No N/A**Approved WPS:** Yes No N/A**Delayed / Cancelled:** Yes No N/A**Bridge No:** 34-0006**Component:** OBG and Tower Fabrication**Summary of Items Observed:**

## WELDING INSPECTION REPORT

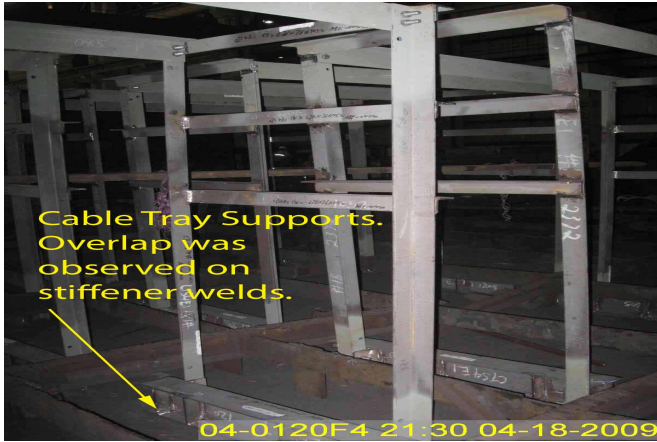
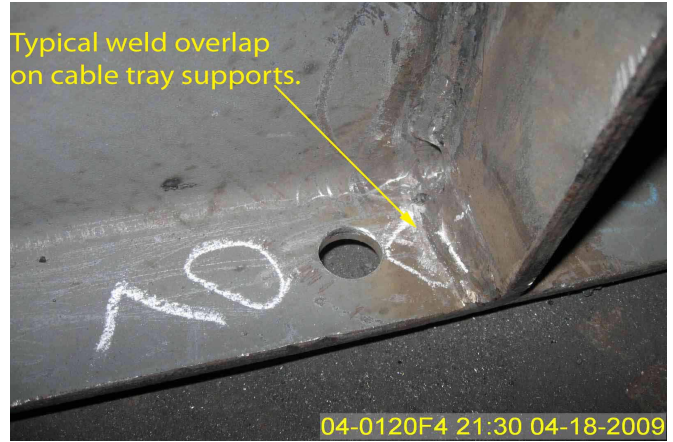
ZPMC QC representative Mr. Testino presented this QA Inspector, Mr. Paul Dawson, with "Inspection Notification Document" #02701 which states nine CTS4E1 (cable tray supports) are ready for Caltrans QA Inspectors to perform visual weld inspection in OBG bay #5. This QA Inspector accompanied Mr. Testino to bay #5 and this QA Inspector performed random observations of stiffener fillet welds on two of the cable tray supports and observed four locations where the welds have overlap or undercut. The QA Inspector informed Mr. Testino

that ZPMC QC Inspectors should reinspect the other five cable tray support assemblies to ensure the remaining welds on cable tray supports do not have similar overlap and undercut problems. At approximately one hour later ZPMC QC personnel informed the QA Inspector that the cable tray support welds have been reinspected and that they are ready for Caltrans QA to perform visual inspections. The QA Inspector performed visual inspection of three additional cable tray supports and five welds were identified as having overlap and two welds with undercut were observed. At around 2130 hours Mr. Lay Tao informed the QA Inspector that ZPMC workers and the QC Inspectors in bay #5 are now going home for the day and that QA visual inspections should be resumed tomorrow. See the photographs below for additional information.
